Waters of the U.S. Determination Report

SR 38 HMA Overlay and Minor Structural in Tippecanoe and Clinton Counties, Indiana Des. No. 1601074 Asset ID#: CV 038-079-07.58

Prepared by:
Hanson Professional Services Inc.
7820 Innovation Blvd, Suite 200
Indianapolis, IN 46278

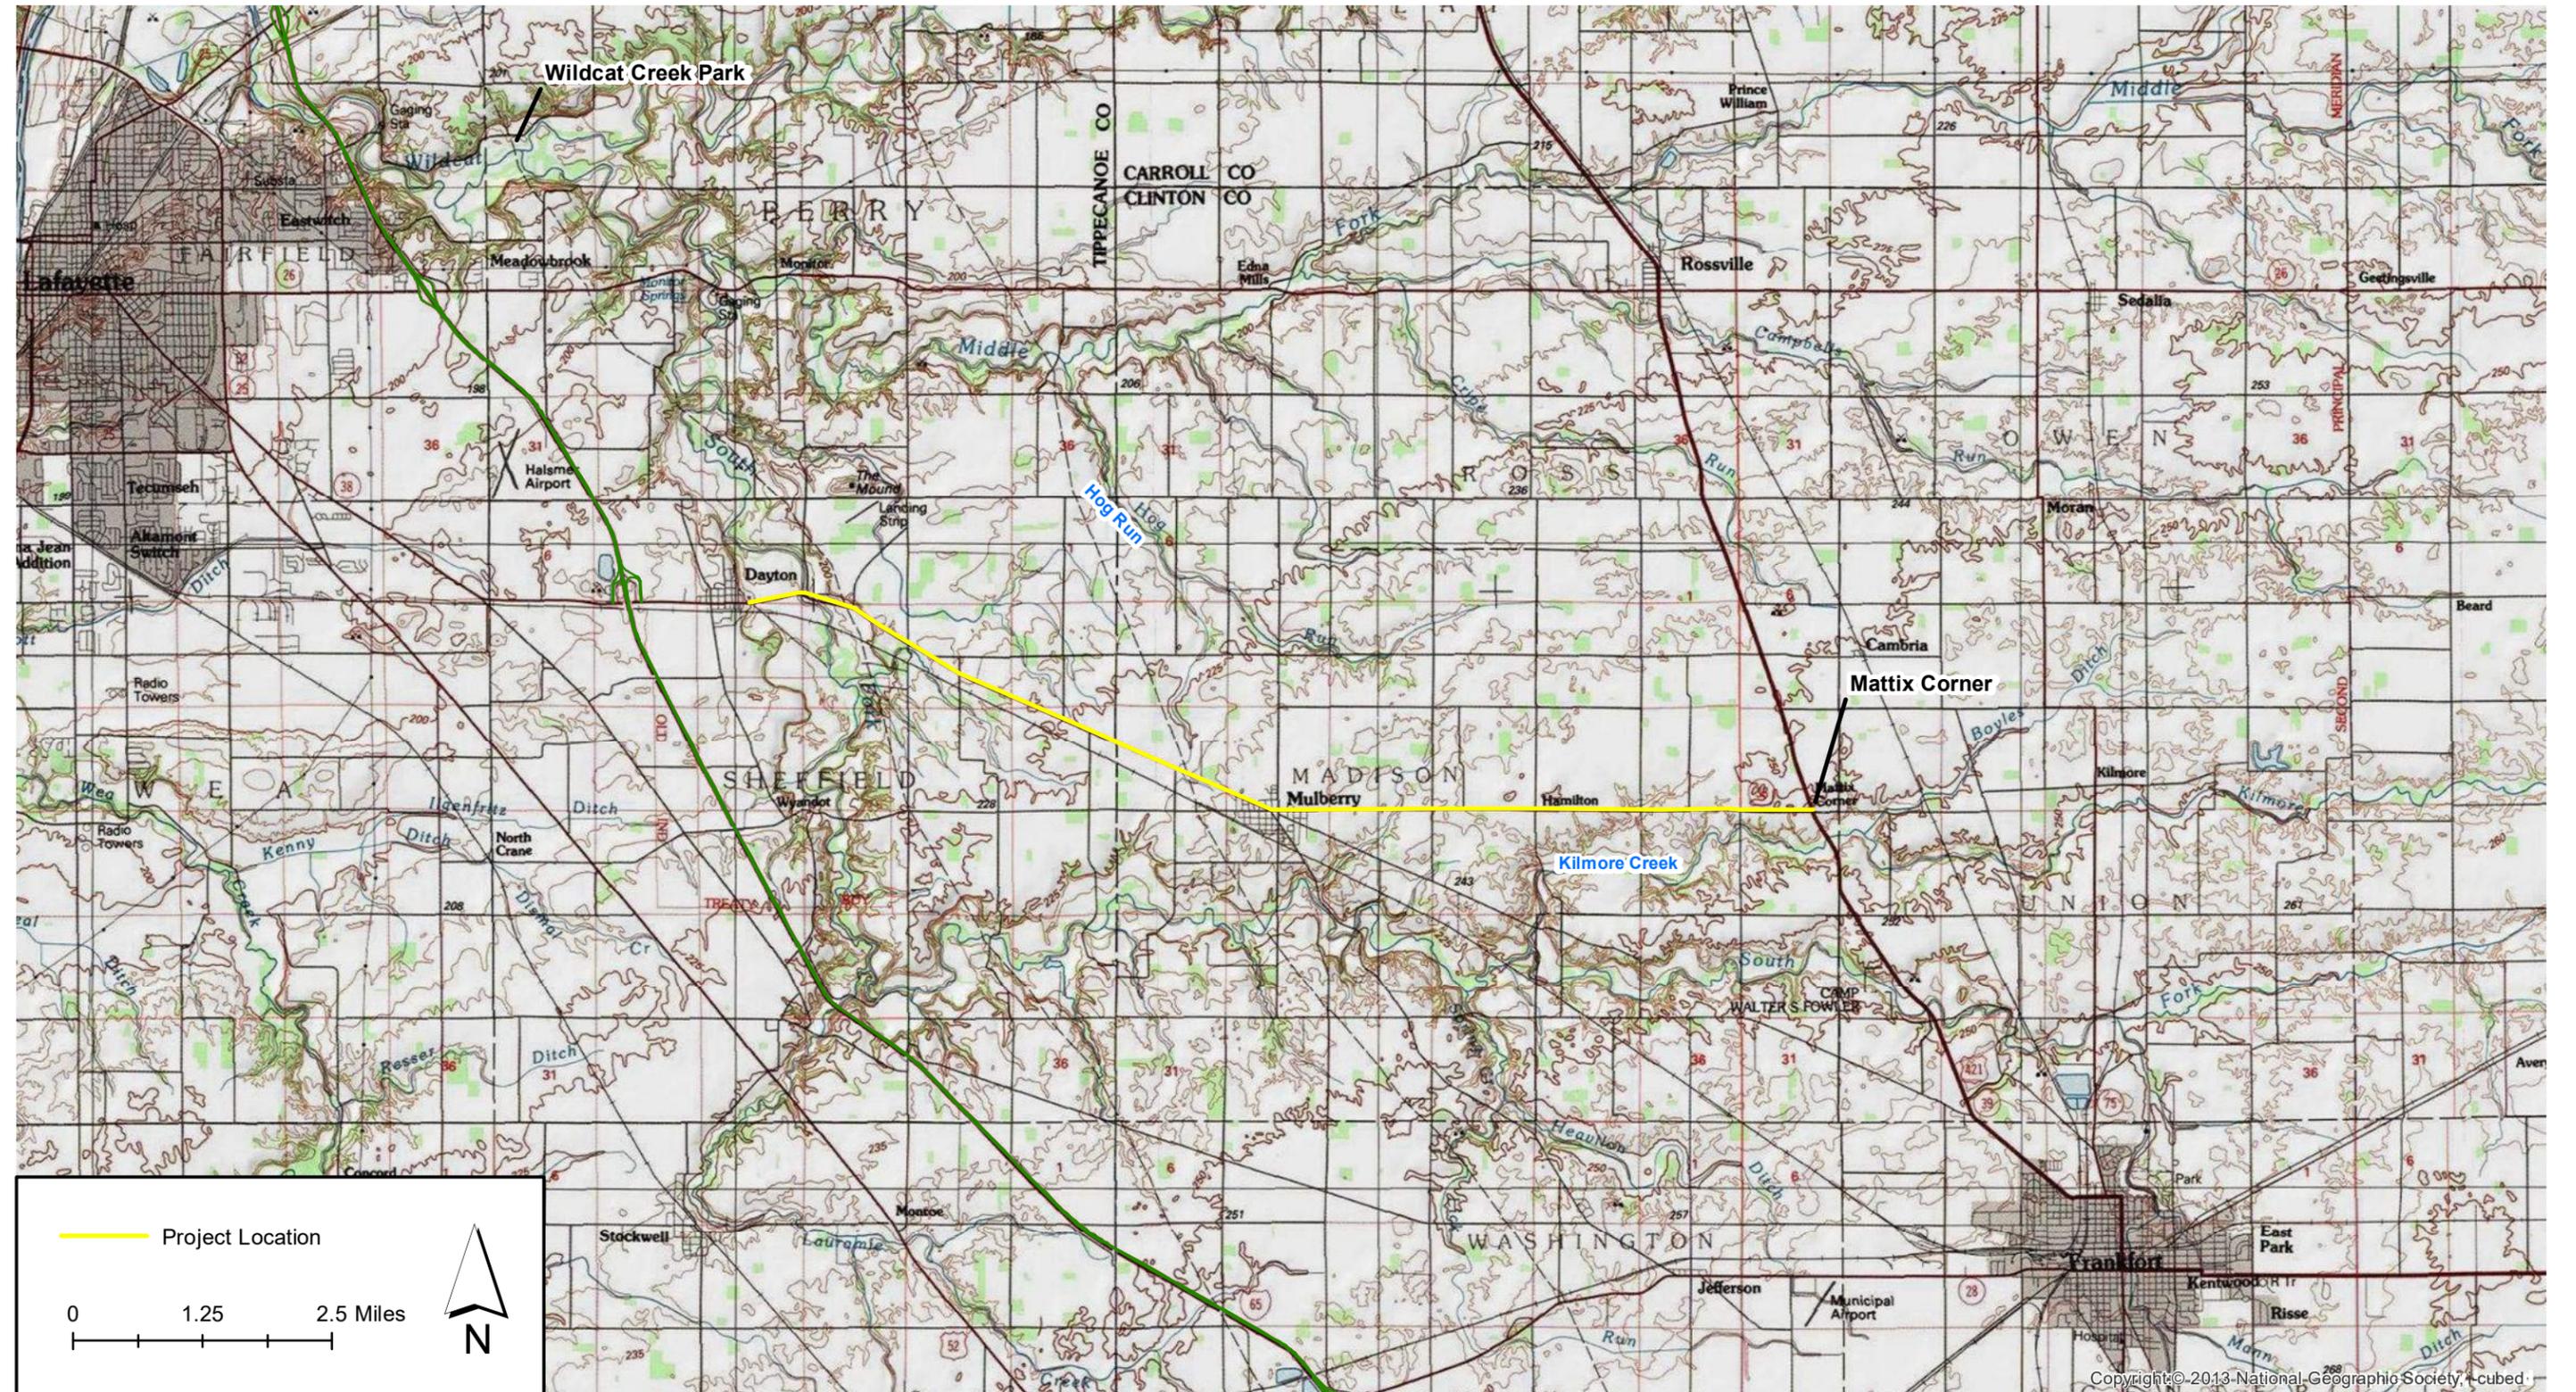
Figure 2A USGS Topographic Map

The USGS Topographic (7.5 minute quadrangle) maps for Lafayette East (1998), Frankfort (1961, photo revised 1991), Mulberry (1961, photo revised 1980), and Stockwell (1961, photo revised 1980) quadrangles were reviewed. The maps depict South Fork Wildcat Creek, one intermittent stream tributary to South Fork Wildcat Creek, three intermittent stream tributaries to Kilmore Creek, and an intermittent stream tributary to Hog Run in the study area (see Figures 2A, 2B and 2C).

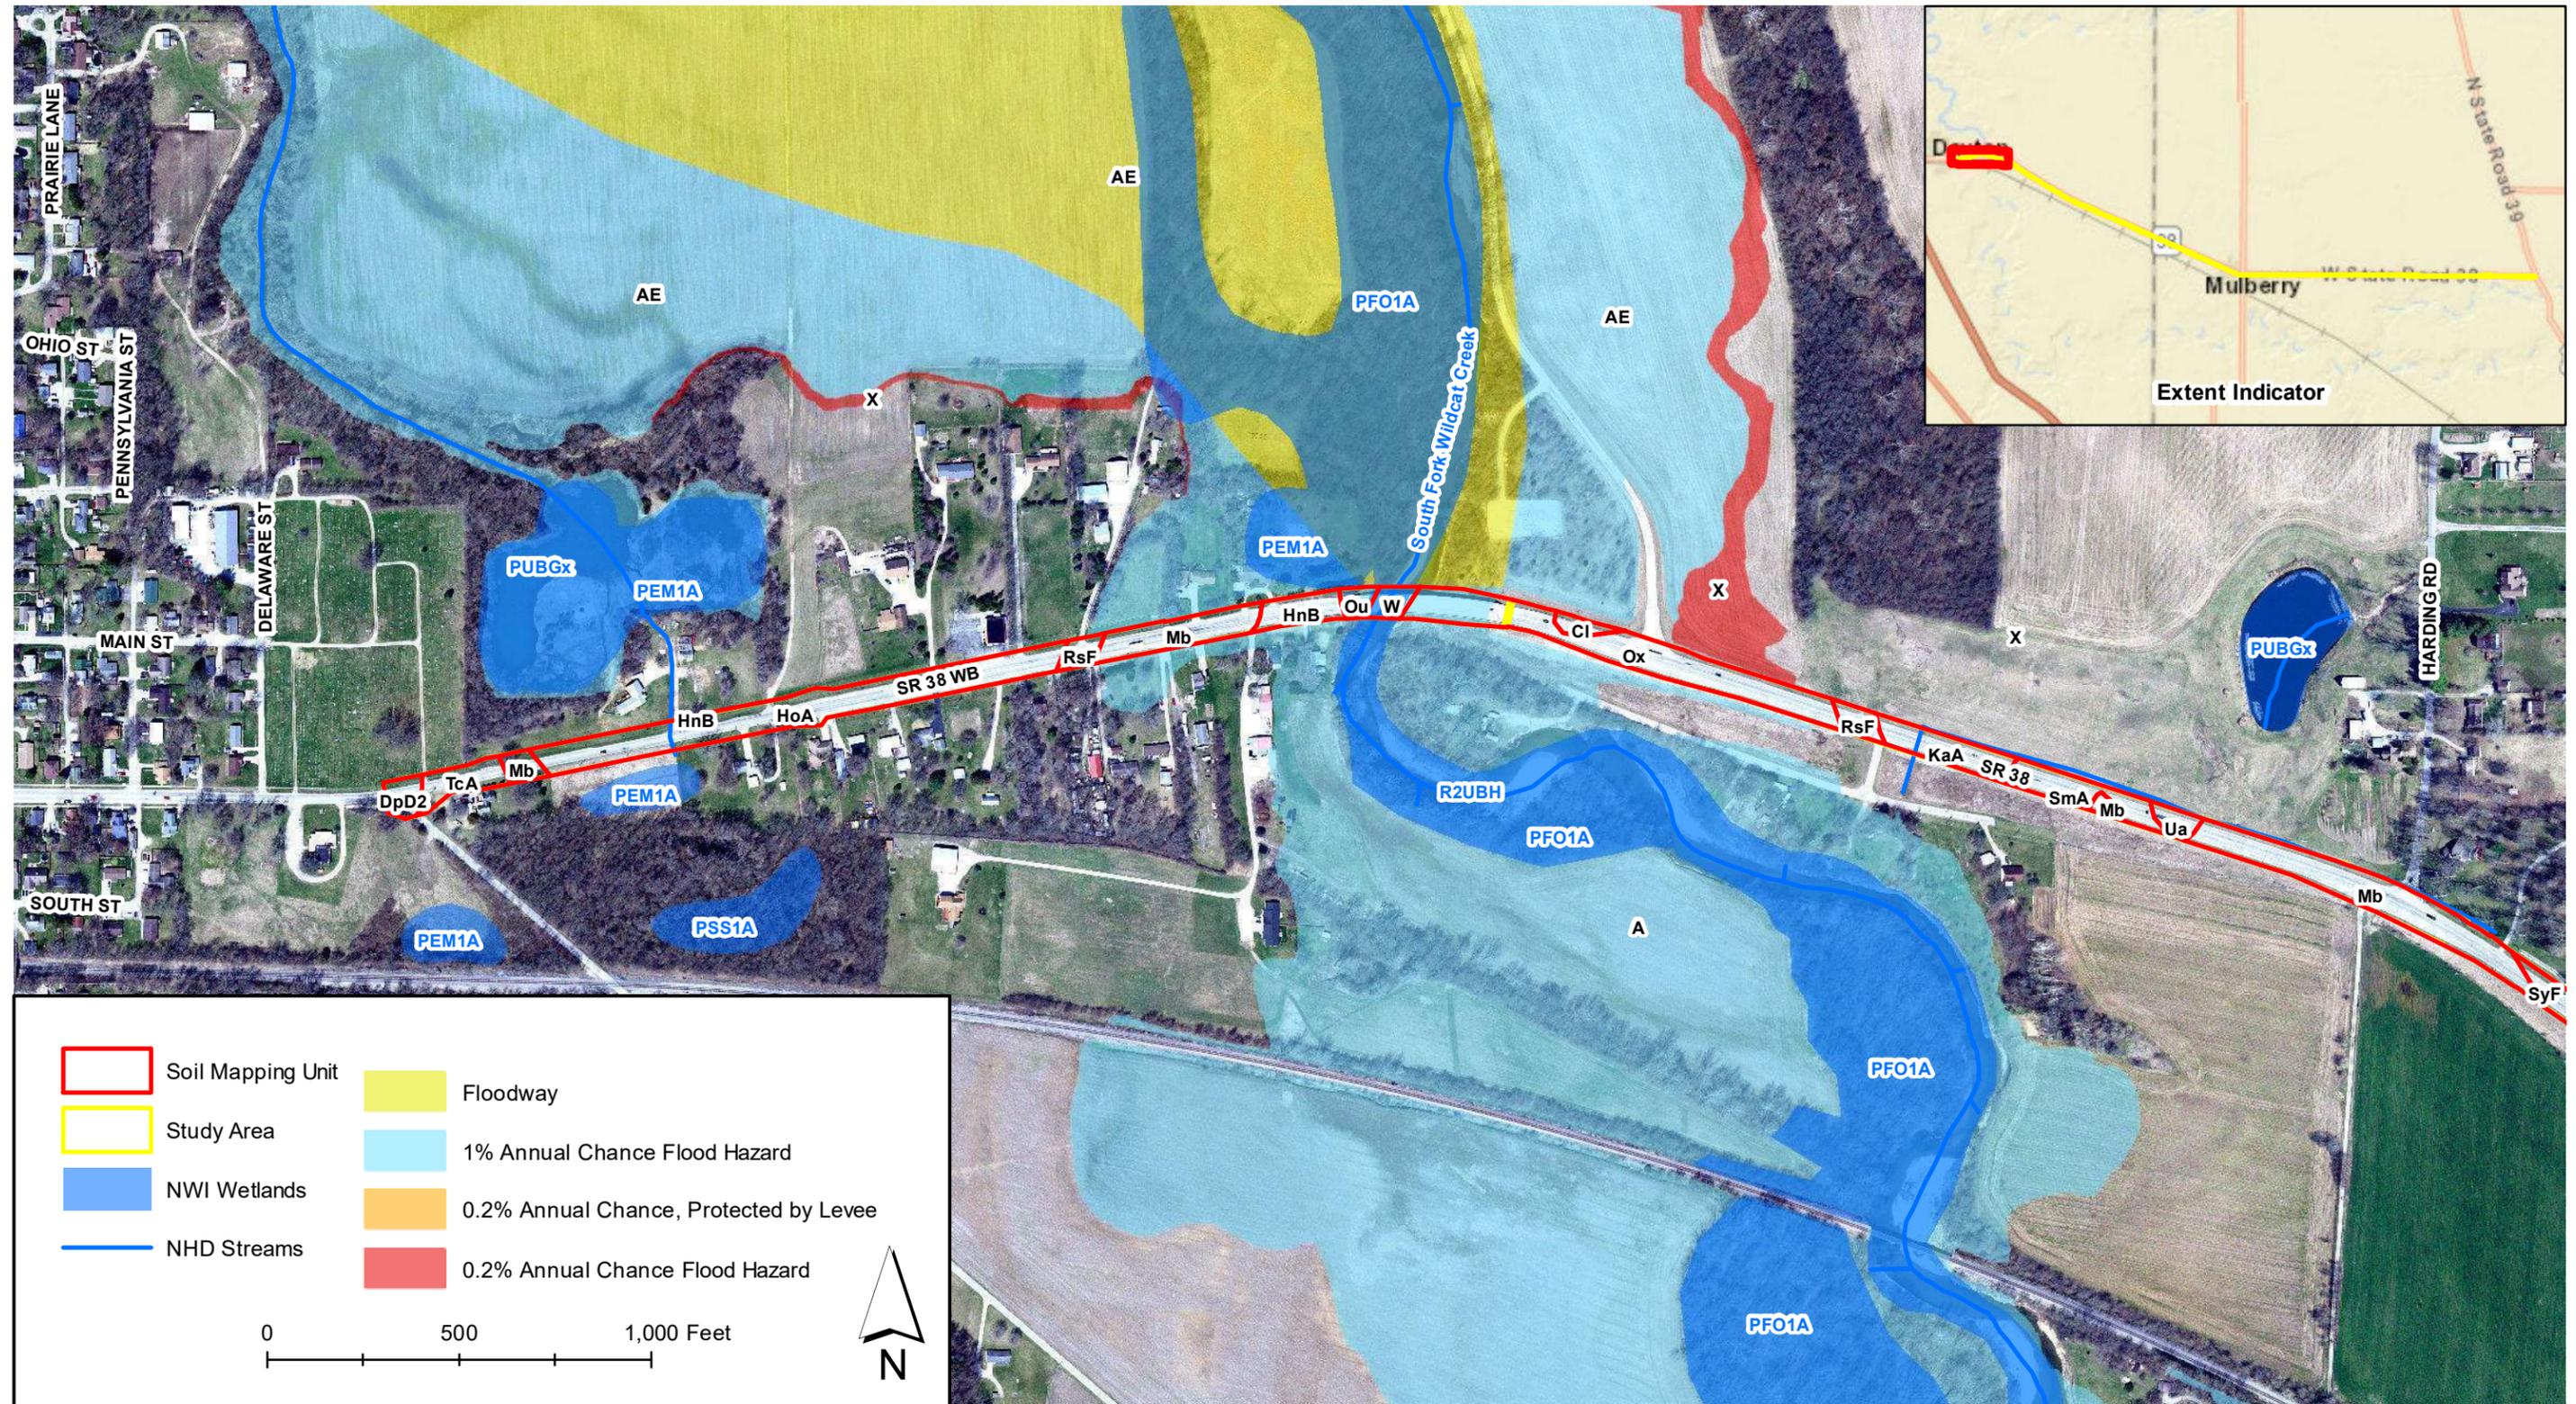
Figure 3 NWI/FIRM/NHD/NRCS Soil Survey Map - Sheet 1

The NWI was reviewed for the study area. The NWI depicts several wetlands and linear water features within a 0.5 mile radius of the study area (see Figure 3 and Table 3). Within the study area, which includes the existing SR 38 corridor and adjacent land approximately 60 feet from the road centerline, three (3) wetland features were observed on the NWI Map. One (1) R2UBH is associated with the South Fork of Wildcat Creek, one (1) PEM1A occurs adjacent to the west of the South Fork of Wildcat Creek, and one (1) PEM1C occurs adjacent to the west of an unnamed tributary to Kilmore Creek.

Based on the December 2, 2011 FIRM for Clinton County, Indiana, Map Number 18023C0130C, and the September 25, 2009 FIRMs for Tippecanoe County, Indiana, Map Numbers 18157C0260D and 18157C0280D the majority of the study area is located within Zone X, which is an Area of Minimal Flood Hazard (See Figure 3). The northwest portion of the study area just east of Dayton is located within Zone A, an area in which No Base Flood Elevations have been determined (See Figure 3). This floodplain area is associated with the South Fork Wildcat Creek.
